Weld qualification test report

Report number LW21-1306-1 WPWQ

Customer Asme Welding Pty Ltd

Description Welder qualification testing

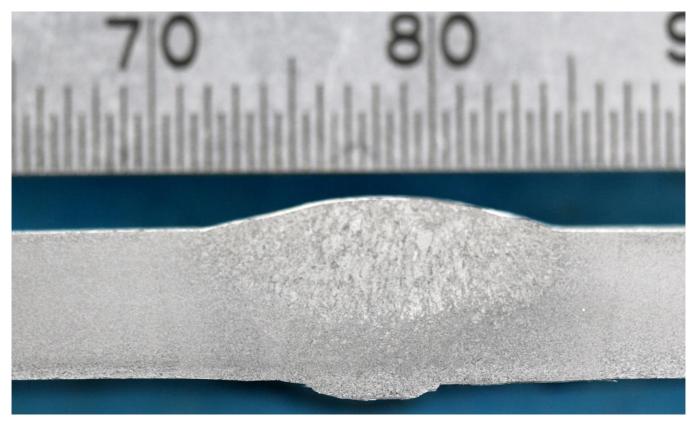
Image 1 of 1 - Macro Specimen 1

Specimen 1 Magnification x 5 approximately (refer to the photograph) Test date 17/07/2021

Weld passes 5

Discontinuities Nil

Comments Nil

Test results The test results comply with the specification requirements.
